Advisory Visit

River Worfe

March 2011

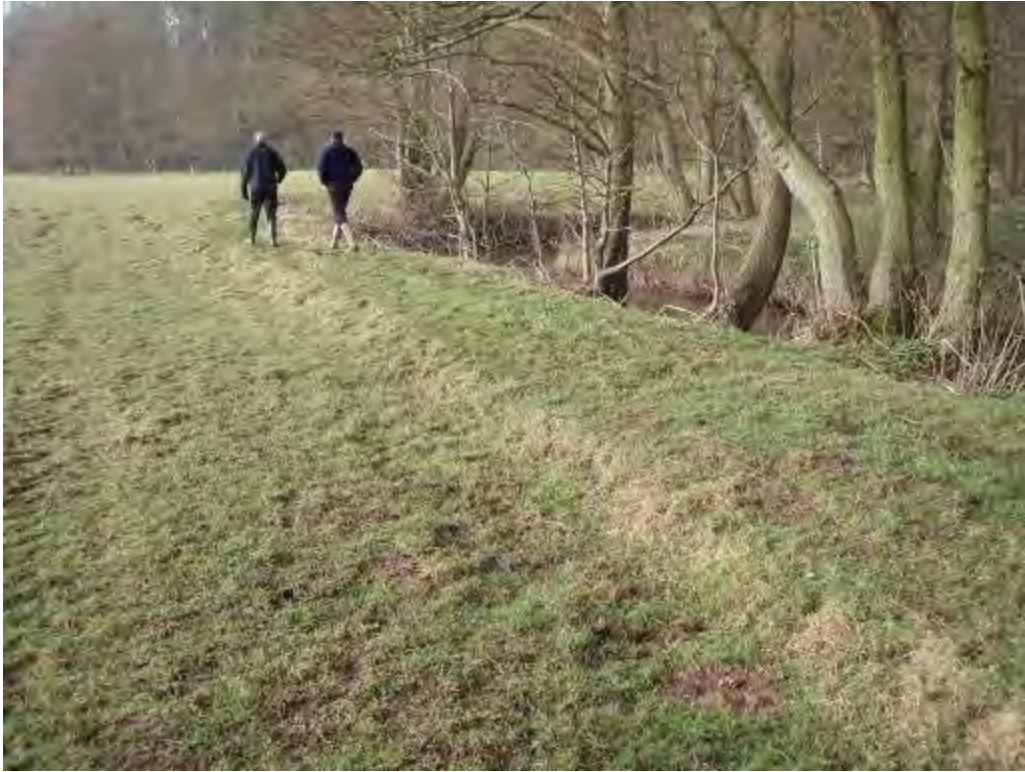
The river here has a meandering planform set in a broad valley cut into the sandstone plateau. The surrounding gently-rolling landscape is used for mixed livestock and arable agriculture and forestry (cover photo). Mature trees are present on both banks, mainly alders, providing a nice balance of light and shade to the river channel. The river was walked along the right bank, which is currently a field being used for sheep grazing; the previous year it had been used for maize cultivation (Photo 1).

Photo 1 Former arable (maize) field now used for sheep grazing; the ploughing contour is still visible. Note the single line of riparian trees.

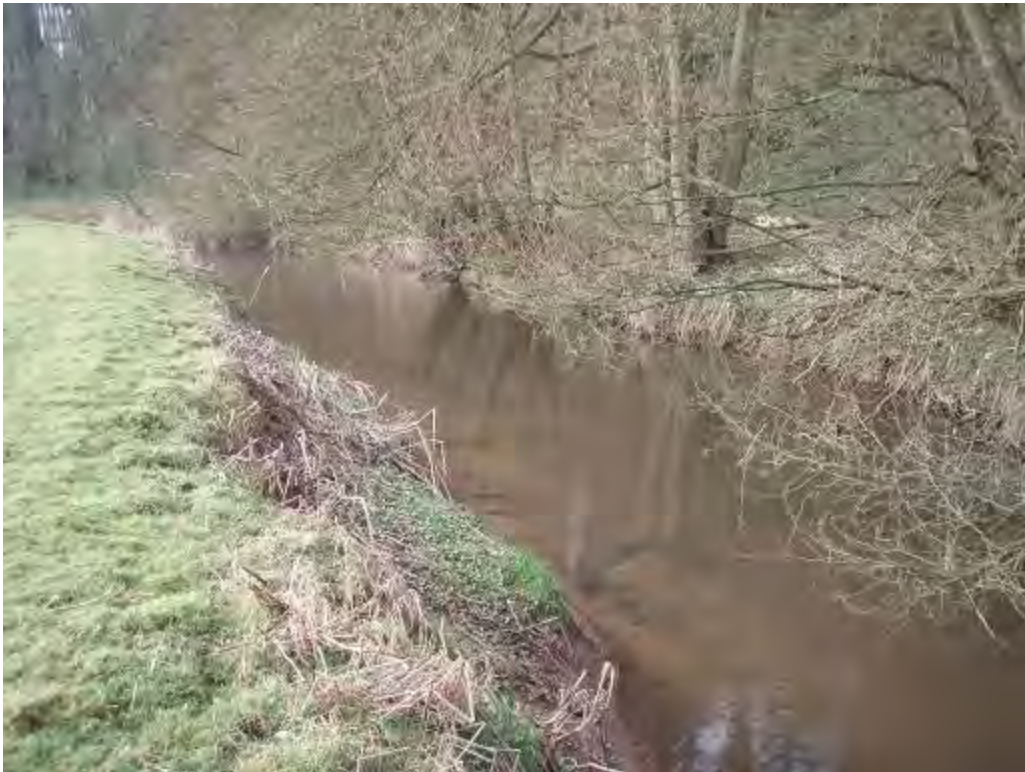
The fundamental characteristics of good lowland river habitat are present here, namely a meandering planform and a varied depth profile. However, the most striking observation is the large volume of fine sediment present on the river bed – literally “dunes” of sand are present and where coarser sediments (gravel, cobbles) are present on riffles, these are embedded within sand (Photos 2, 3). Whilst this is undoubtedly a phenomenon associated with the sandstone geology and associated sandy soils, the extent of the sediment accumulation indicates an increased rate of supply of fine sediment to the river. Changes in agricultural practices are a likely reason for increases in fine sediment supply, for example increases in arable cultivation (Simon Cumming, pers.comm.). Soil erosion from maize cultivation in the immediate vicinity of this site was evident last year according to Tony Bostock.

The accumulation of fine sediment is a major problem for successful breeding of trout and salmon. Both species spawn in the autumn/winter and their eggs remain buried in the gravel until the following spring. Fine sediments fill the gaps between the gravel, blocking the supply of fresh water and causing the eggs to suffocate. Various methods of improving the quality of spawning gravels are available, such as gravel cleaning (with water pumps or leaf blowers) and installing structures to locally scour away fine sediment. However, these are “sticking plaster” solutions, treating the symptom rather than the cause; alongside these measures, the supply of fine sediment needs to be tackled at source and on a catchment scale. The large volume of fine sediment currently present in the Worfe suggests that gravel-cleaning remedies would be ineffective and effort should be targeted on soil conservation measures within the catchment.

Photo 2 Large accumulations of fine sediment visible on the river bed.

- Investigate catchment sources of fine sediment and options for control
- Create and maintain riparian buffer strips to encourage tree succession, along with soft revetment of rapidly eroding areas.
- Restore flow to the leat and create a spawning channel
- Control Himalayan balsam

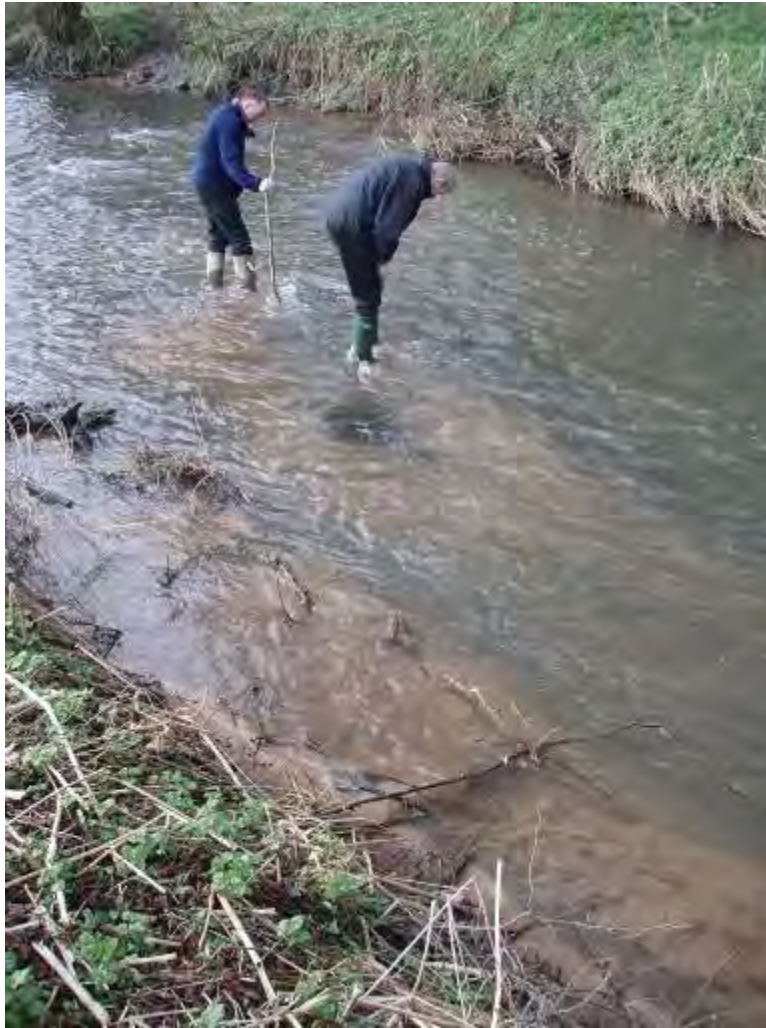
Photo 3 Gravel riffle areas also have large accumulations of fine sediment

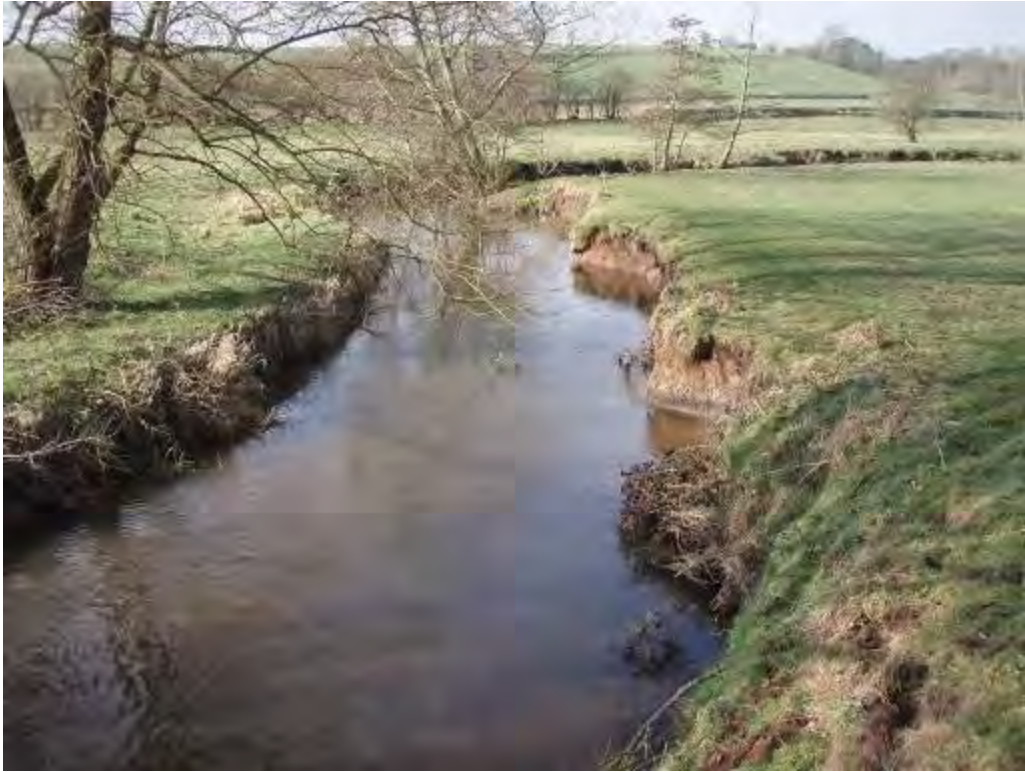
The bankside trees present were mainly mature alders. Some were displaying signs of *Phytophthora* disease, although by no means to the great extent seen on other Severn tributaries such as the Clun. There is no succession of younger trees here, so as trees are lost the bank becomes vulnerable to increased rates of erosion. This was evident in some areas of this site where fewer trees were present (Photo 4). Creation of a riparian buffer strip (protected from grazing) to allow natural tree colonisation and/or native tree planting is recommended, although note the maintenance requirement this creates (see below). Bank protection using soft revetment techniques may be necessary where trees have been lost, to provide increased bank stability whilst tree re-colonisation takes place.

Photo 4 Areas with fewer trees tend to have accelerated rates of bank erosion and a wider, shallower channel. Bank revetment using “soft” techniques (brushwood) are necessary here along with buffer strip creation.

In areas such as that shown in Photo 4, the establishment of a healthy riparian zone should be a priority. This should involve protection of the banks where accelerated rates of erosion are occurring; this can be achieved using soft revetment techniques (Photo 16). A buffer strip, ideally 10 metres wide, should be fenced out to prevent livestock grazing and a mixture of native trees should be planted inside the buffer strip, including ash *Fraxinus excelsior*, hazel *Corylus avellana*, field maple *Acer campestre*, hawthorn *Crataegus monogyna*, blackthorn *Prunus spinosa*, and goat willow *Salix caprea*.

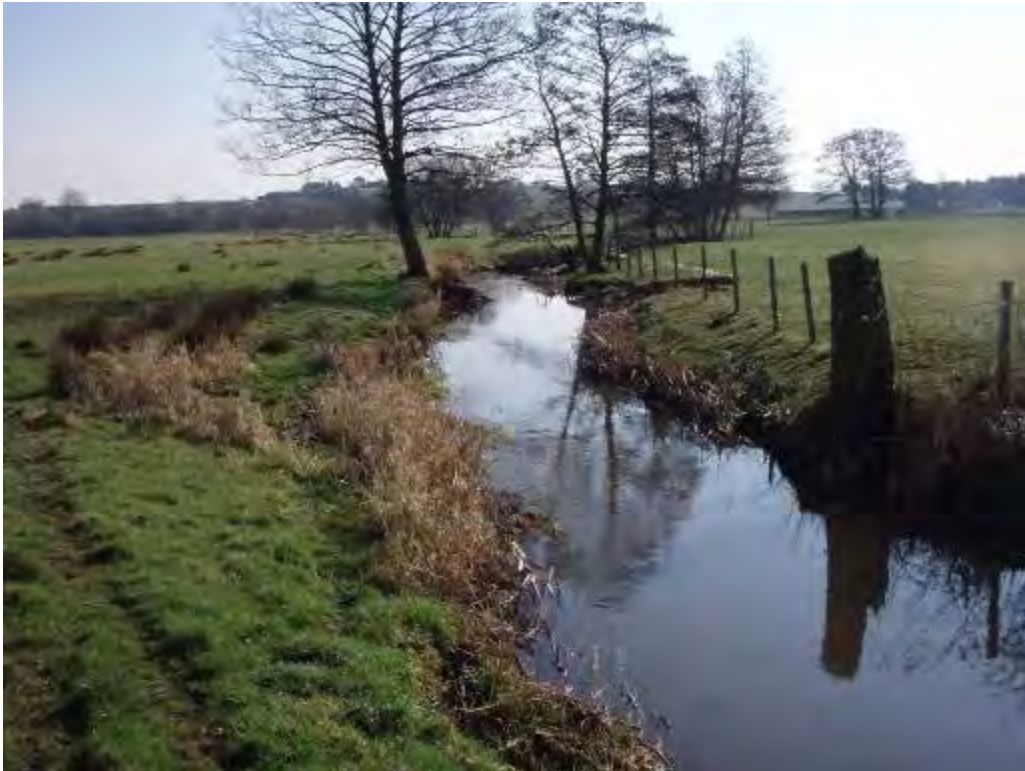
There are fewer trees along this stretch and more evidence of *Phytophthora* disease affecting the alders. Again there is no tree succession taking place, so trees that are lost are not being replaced, with implications for bank stability, shading, water temperature and in-channel habitat. The fields on both banks are rather wet, rushy pasture which is providing an environment for ground-nesting birds like snipe and lapwing (both observed on this visit); the left bank is fenced off (on the initiative of the fishing club) but only 3 strands of barbed wire have been used and sheep are clearly grazing freely on the river side of the fence (Photo 6).

Photo 6 Upstream of Worfield (upstream view)

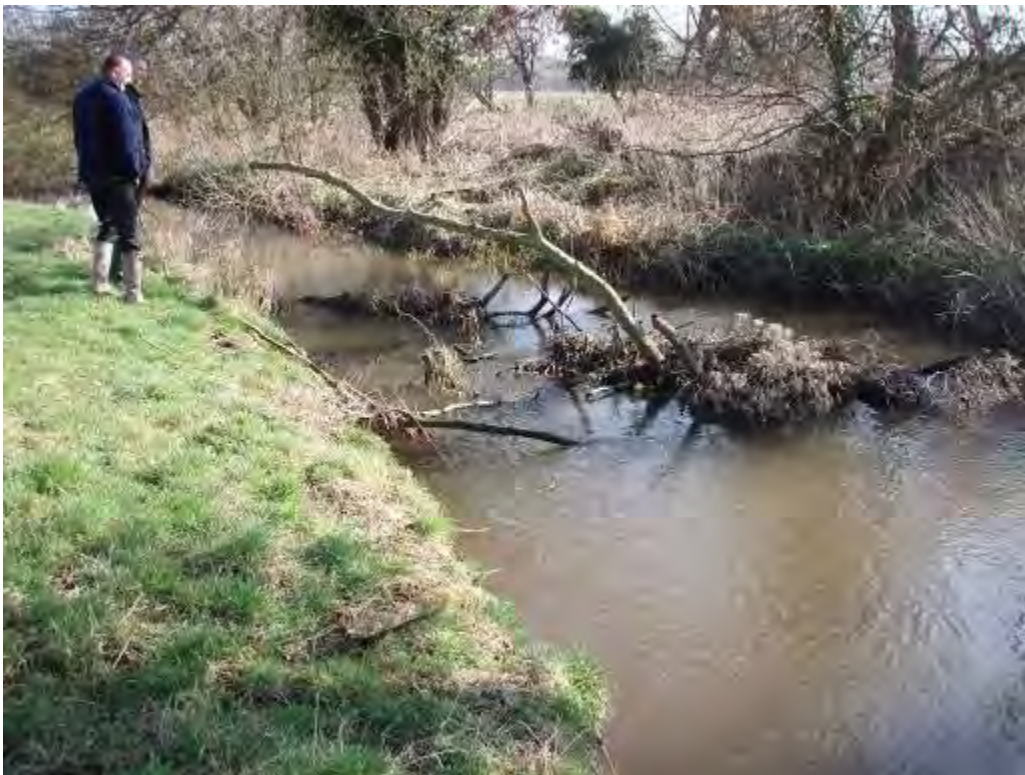
A number of alder trees have fallen into the river channel creating some good in-channel habitat in the form of large woody debris (LWD); this should be retained, but serious consideration given to tree succession so LWD is available in the long-term (Photo 7). Planting blocks of trees and protecting them from grazing may be a better solution than creating a long riparian buffer zone here. This will reduce the maintenance burden (balsam control).

Photo 7 Large woody debris (LWD) – good habitat, but where will it come from in future?

- Create some blocks of trees
- Introduce in-stream structures as described in the Recommendations section

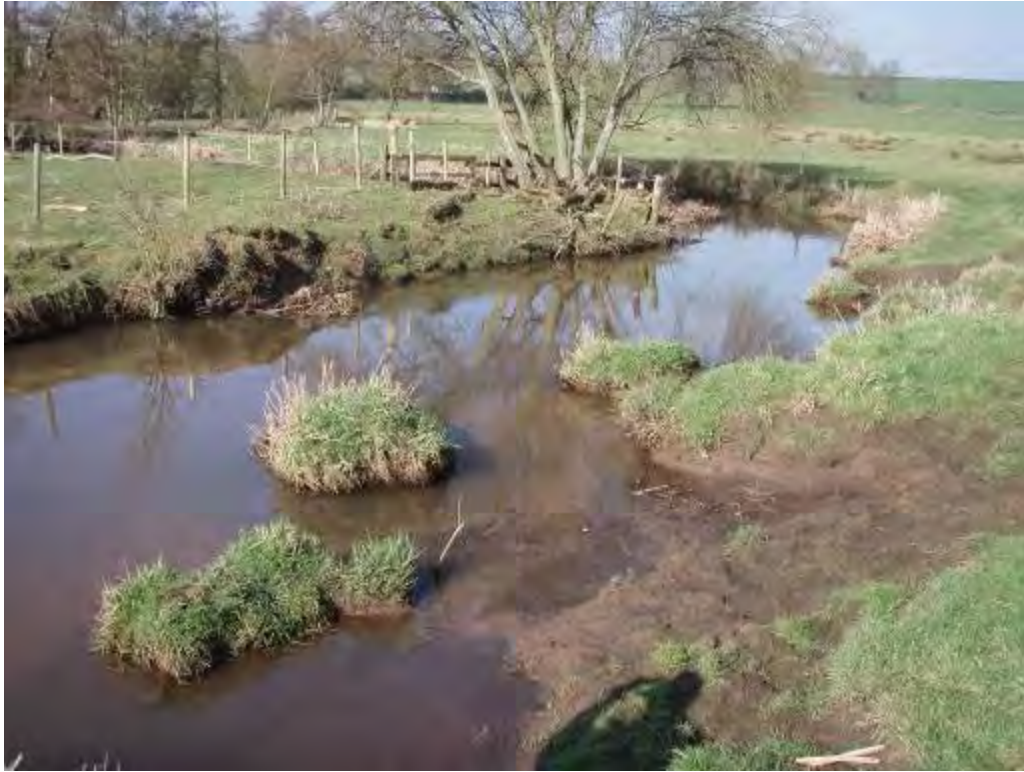
On the right bank, there is an area that has been heavily poached by livestock, over-widening the channel and promoting the deposition of large amounts of fine sediment (Photo 8). However, this is an isolated area and the majority of the banks are not affected in this way.

Photo 8 Area of poached bank

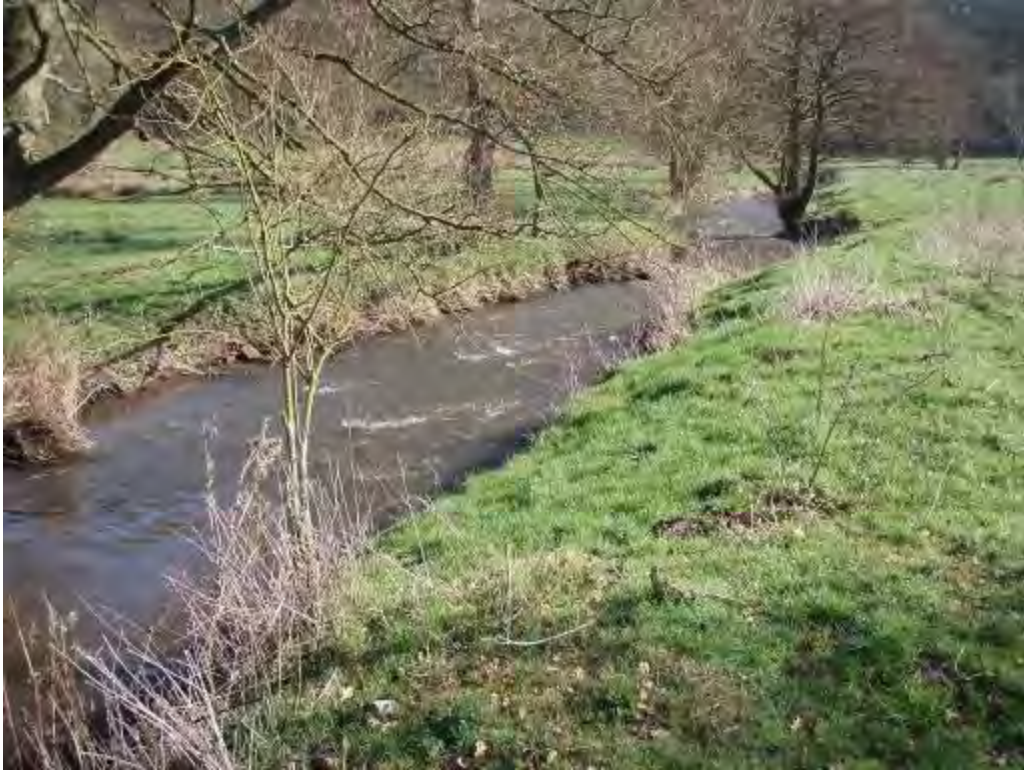
Downstream of the farm bridge (SO 76533 98017; where the SFF catch return box is located) there is a short section of steeper gradient channel forming a faster flowing riffle area (Photo 9). Some gravel raking has been carried out here previously and small trout have been recorded in catch returns, indicating some successful spawning. However, large amounts of fine sediment are present throughout the whole of this section, including between the gravel on this riffle area. Pegging some logs to the river bed here to create localised scour and areas of gravel free from fine sediment would be beneficial.

Photo 9 Steeper gradient section downstream of farm bridge

- Peg some logs onto the riffle section below the farm bridge to create localised scour
- Create some pinch points in the straighter sections of the channel as described in the Recommendations section.

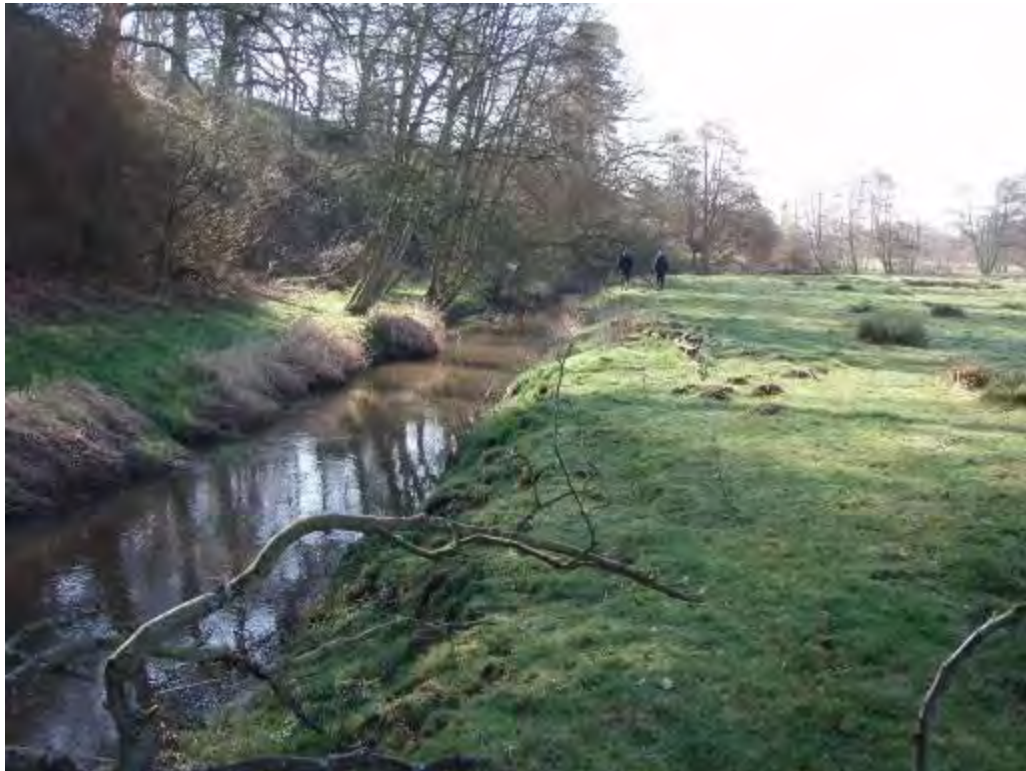
Continuing downstream, the river bed gradient lessens and the channel becomes rather uniform in terms of width and depth (shallow). Alongside the sandstone bluff on the left bank, the river channel is very straight, but becomes more meandering with downstream progress (Photo 10). The uniform sections could be improved by creating pinch points within the channel using flow deflectors, woody debris and/or channel re-profiling with an excavator (the "Nigel Holmes method") – see recommendations.

Photo 10 Straight section downstream of area in Photo 9

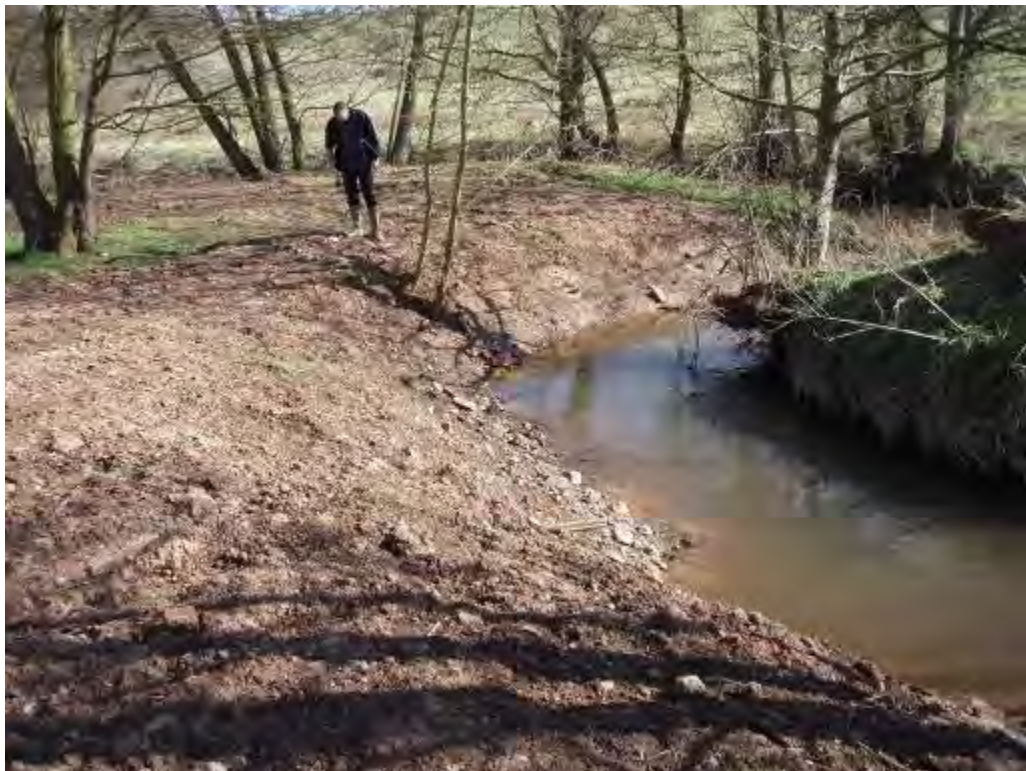
The trapezoidal cross-section of the channel suggests past land drainage works, and probable lowering of the river bed. Bank reinforcement and re-profiling has been carried out on sections of the right bank using hardcore rubble and topsoil (Photo 11). Some of this work is recent and some is older; the older work appears to have stabilised and vegetated, but it creates a somewhat sterile margin along the river and a steep bank profile. Use of different techniques including soft revetment and creation of a marginal berm would be better for wildlife, fisheries and amenity (angling access).

Photo 11 Recent bank works

Figure 3 Cut-and-fill technique can be used to create features like D-groynes (Figure 4 below) to create width and depth variation in the channel, or to create marginal ledges (e.g. in areas such as Photo 11).

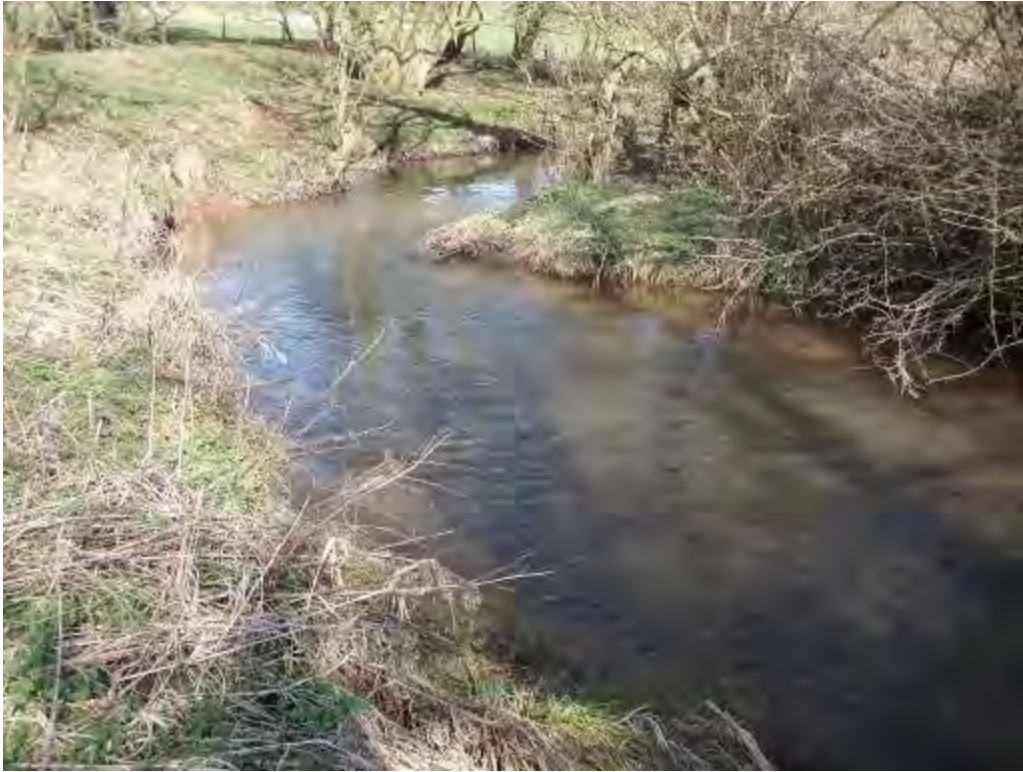
Photo 12

At a point where an old mill leat used to re-enter the river channel there is a high point in the river bed with some good quality spawning habitat; the gravels are well-sorted and relatively free of fine sediment (Photo 12). This is the only area of such habitat seen on this visit which emphasises how successful spawning is very likely to be the factor limiting wild trout populations in the Worfe.

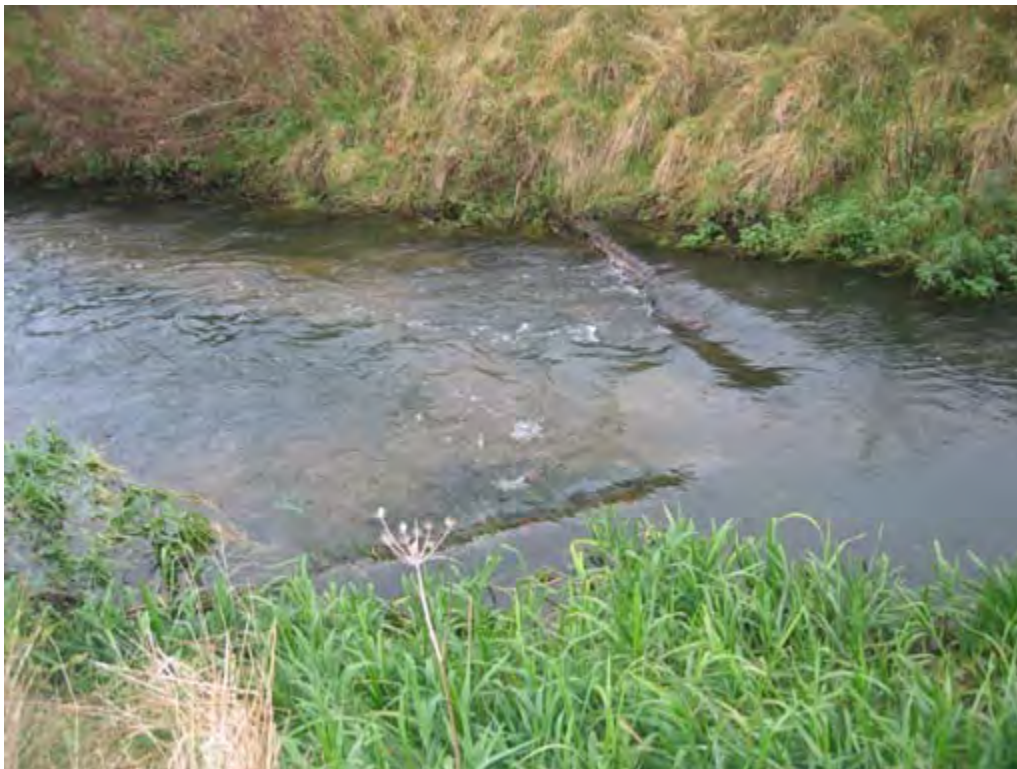
Photo 13 Paired log flow deflectors

- Creating pinch-points within the straighter sections of river channel to encourage bed scour and prevent the deposition of fine sediments in these areas. The pinch-points can be created in a variety of ways, including the introduction of large woody debris (root-wads, logs); channel narrowing (cut-and-fill technique; brushwood mattress); and manipulation of the river channel profile with an excavator. Examples of these various methods are illustrated below (Photos 13-16, Figures 3-4).

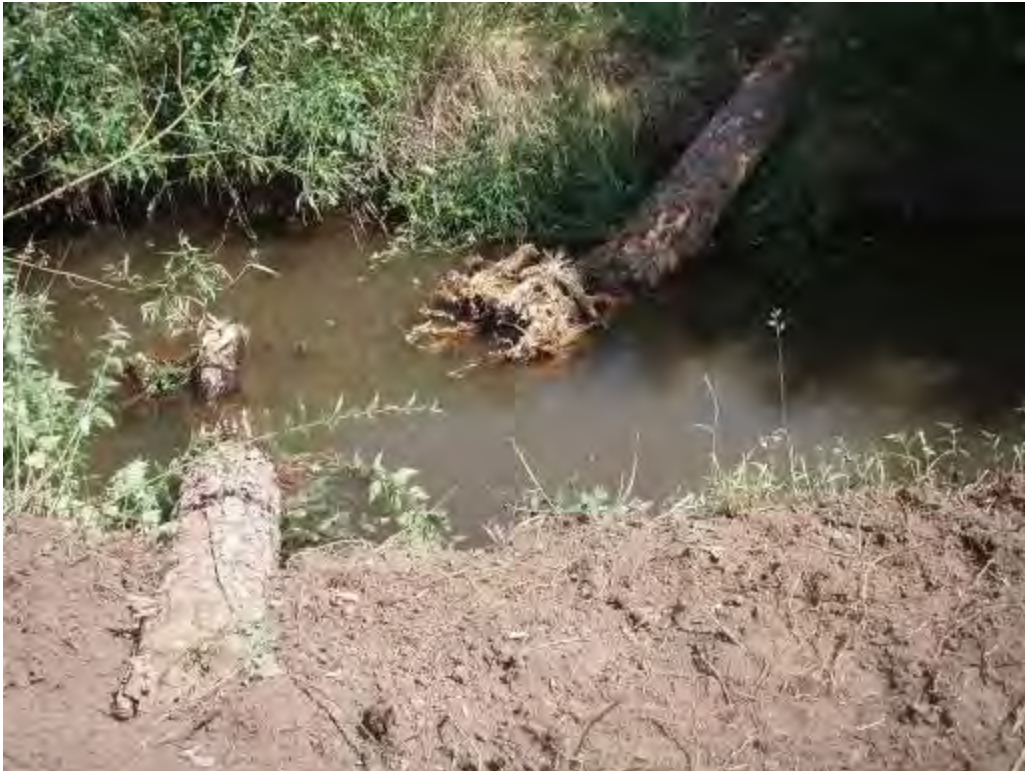
Photo 14 Root wads introduced to provide some in-channel structure and scour

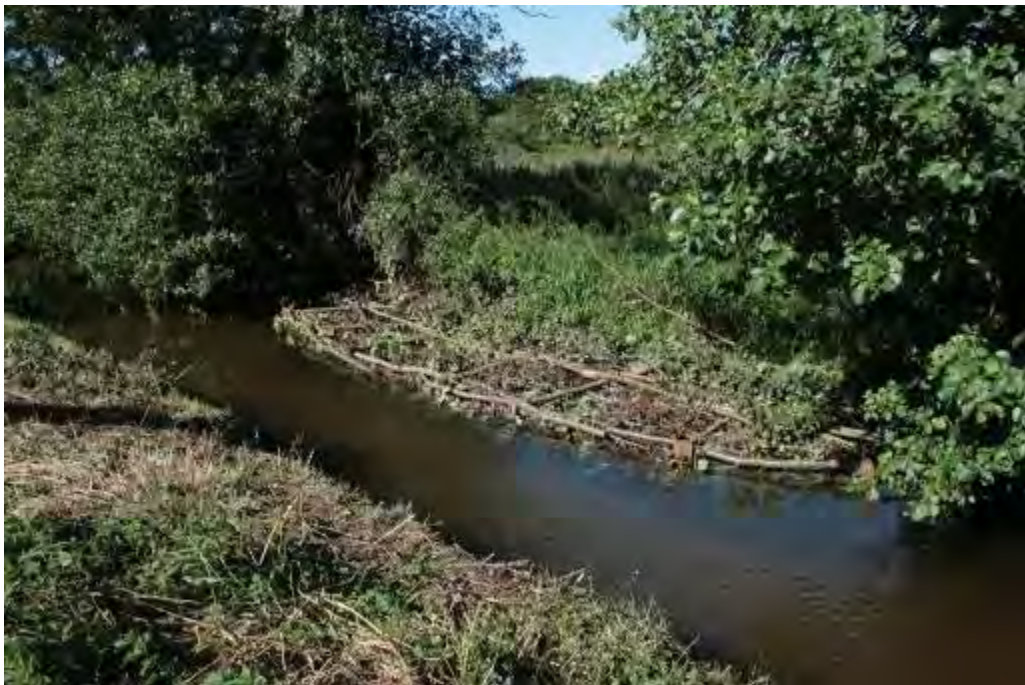
Photo 15 Brushwood mattress consisting of branches from tree coppicing staked and battened or wired down. The mattress accumulated fine sediment and vegetates, narrowing and deepening the channel.

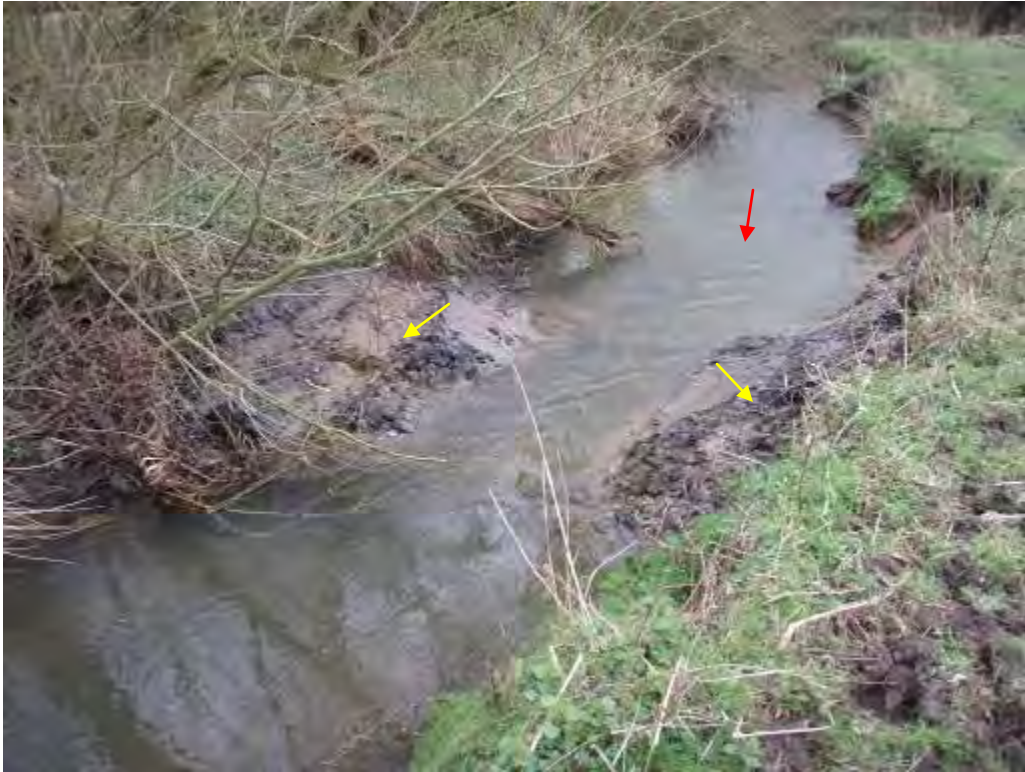
Photo 16 Direct remodelling of the river channel with an excavator can be a quick and cheap method of increasing the diversity of the channel form in lowland rivers. Here a deep pool has been excavated (red arrow) and the material used to make “shoulders” upstream of the pool (yellow arrows) to pinch the channel and create scour which will maintain the pool depth.

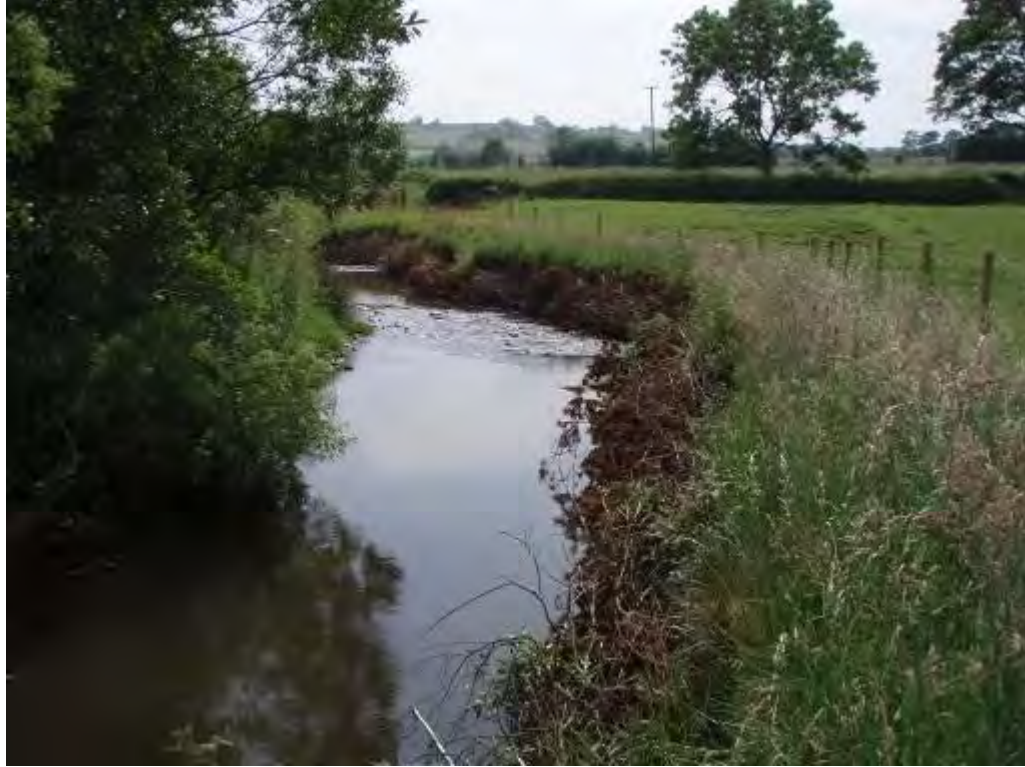
Photo 17 Brushwood revetment installed along an eroding bank, which was then fenced. Photo taken 8 months after installation. Trees have subsequently been planted here.
